Emergent Repair of Glasair I TD Wing

AirVenture July 25th, 2019

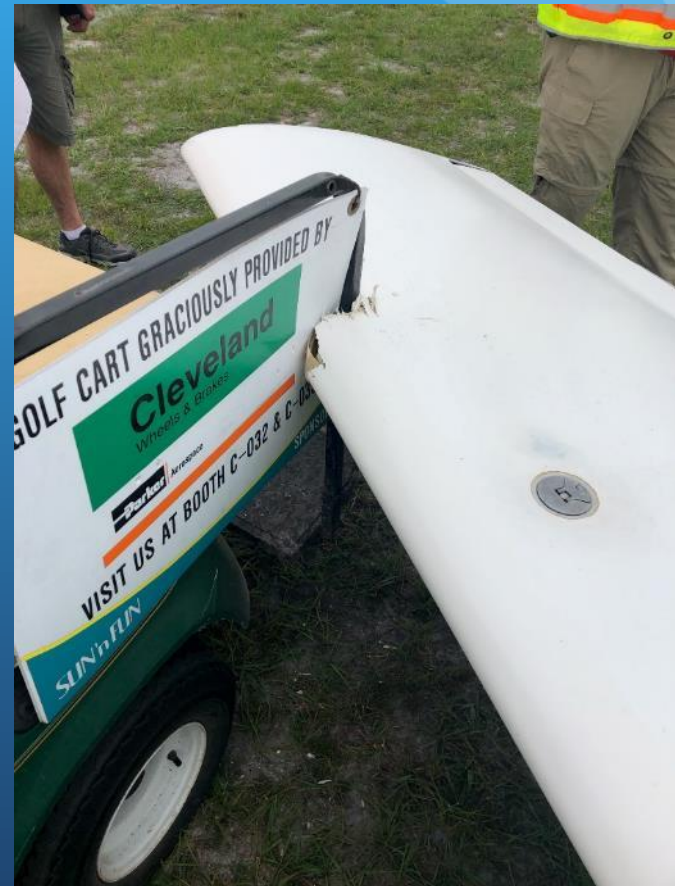
Initial Damage

- Due to a blind spot in field of view Glasair TD pilot strikes leading edge of wing into a golf cart at Sun N Fun 2019 while being marshaled.
- Simple steps were taken to restore the damaged wing to full strength.
- This method is applicable to many types of composite damage of non-primary structure.

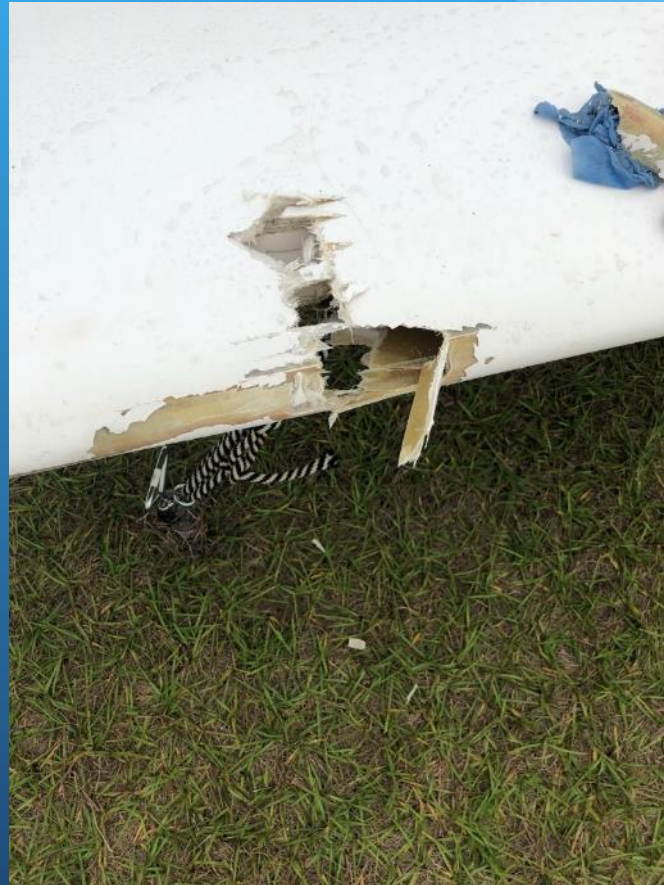
Close Look at the Damage

Good news is that there is no spar or fuel tank impact.
